#### Reside

#### Heater

#### Heatter Maintenance Challenges Grid Can Orifice Erosion

Heater Maintenance Challenges

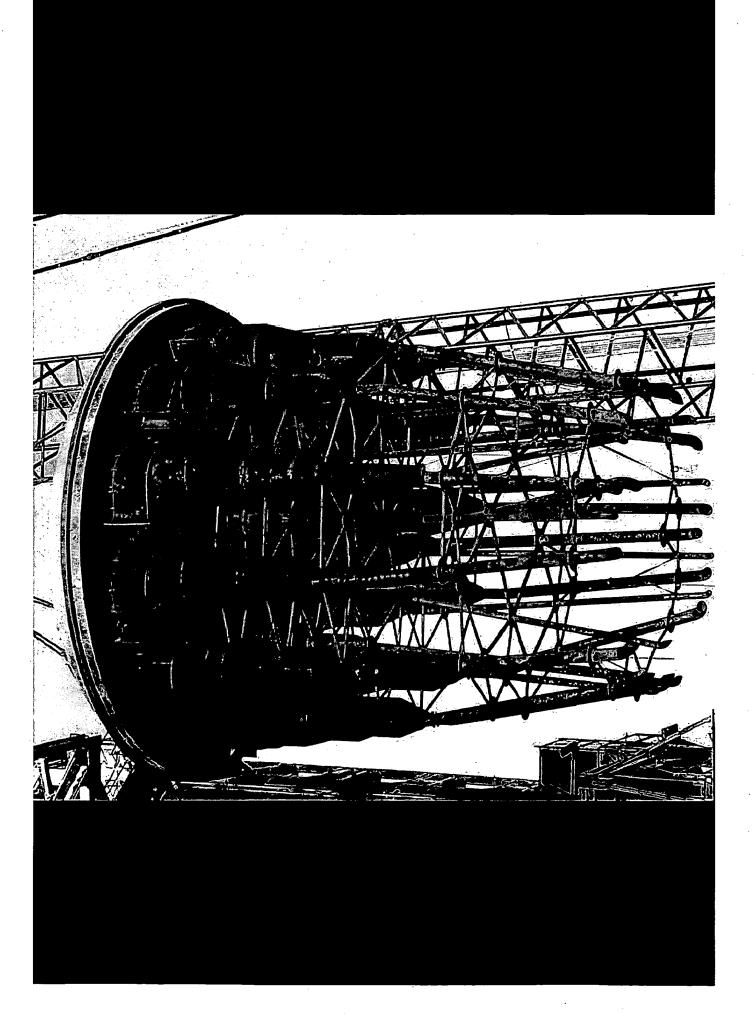
Carburization of Stainless Steel

All internals stainless steel: 18% Cr/8% Ni 0

Temperature range 590 - 635°C

o Gas contains H<sub>22</sub> CO and H<sub>2</sub>S

CO reacts with Cr to chromium carbides 0

Hzs corrosion of steel due to reduced Cr content 0

o Cyclones replaced in last turnaround
